Manhole Inspection Summary

Manhole # S41I__051MH

Insp Date: **5/14/08 9:23 AM**

Location Address: **side of 1419 bank st**

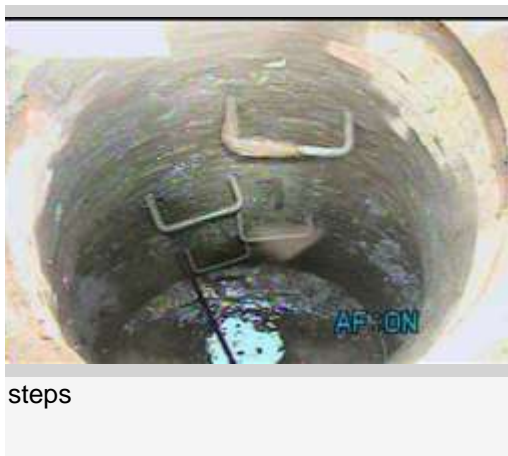
Defect 2

Steps Count: **4** Missing: **0** ☒ **Corroded**

steps

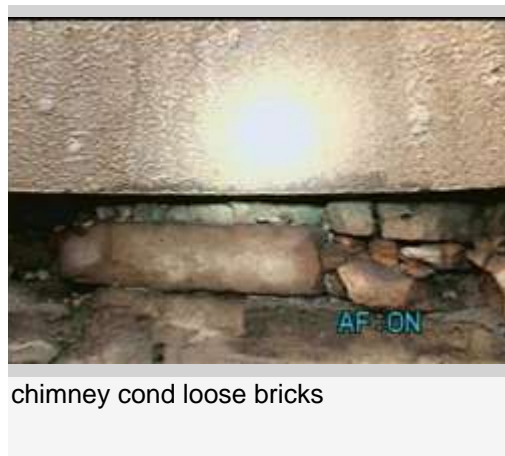
Defect 1

Condition: ☐ Sound ☐ Cracked ☐ Root Intrusion ☒ **Loose Brick** ☐ Deteriorated

chimney cond loose bricks
